MUTHANNA VILLAGE ROADS
SEGMENT 4
GOVERNORATE OF
MUTHANNA, IRAQ

PROJECT NUMBER SIGIR-PA-06-055

JUNE 30, 2006

SUBJECT: Report on Project Assessment of the Multhanna Village Roads Segment 4,
Muthanna Governorate, Iraq (Report Number SIGIR-PA-06-055)

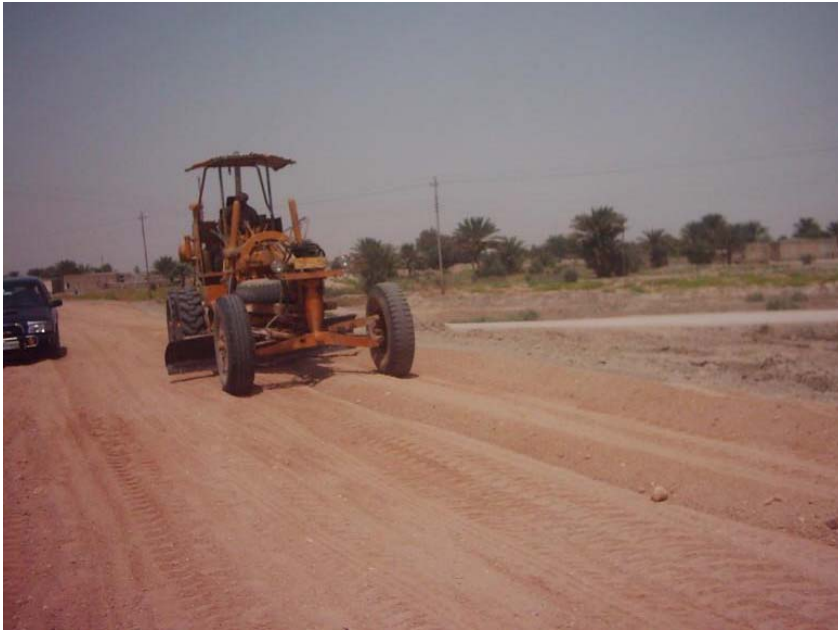
Based on a review of the quality assurance reports and photos, it appeared the contractor used suitable material for constructing the sub-base. The contractor would deliver the material to the roadway, and then spread and level the material with a motor grader as shown in Site Photo 1.

Site Photo 1. Contractor motor grader leveling the sub-base – Photo provided by USACE

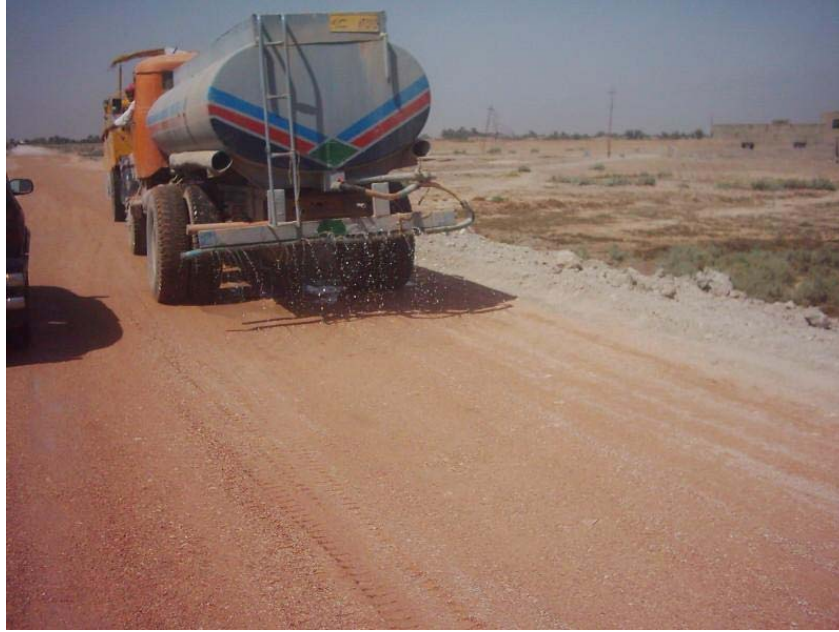
To achieve the compaction requirements stated in the Iraq Standard Specifications for Roads and Bridges, the Contractor added water as shown in Site Photo 2 to spread the sub-base material in order to achieve an optimum moisture content⁴ to facilitate proper compaction.

Site Photo 2. Water distributor adding moisture to the sub-base – Photo provided by USACE

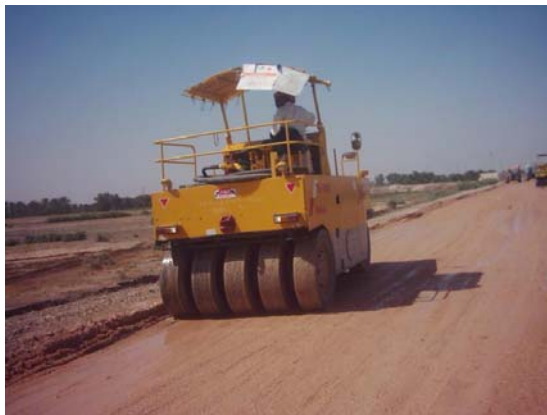
Site Photo 3. Compacting the sub-base with a pneumatic rubber tired roller – Photo provided by USACE

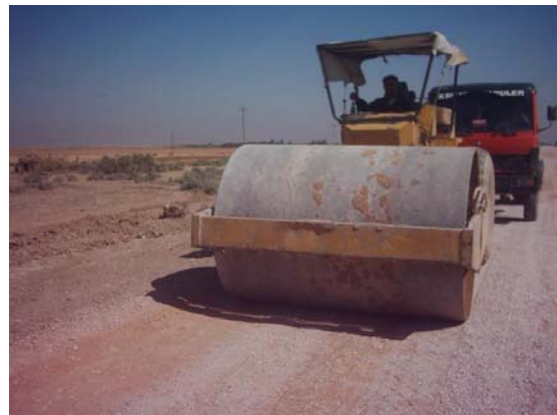
Site Photo 4. Compacting the sub-base with a steel wheeled roller – Photo provided by USACE

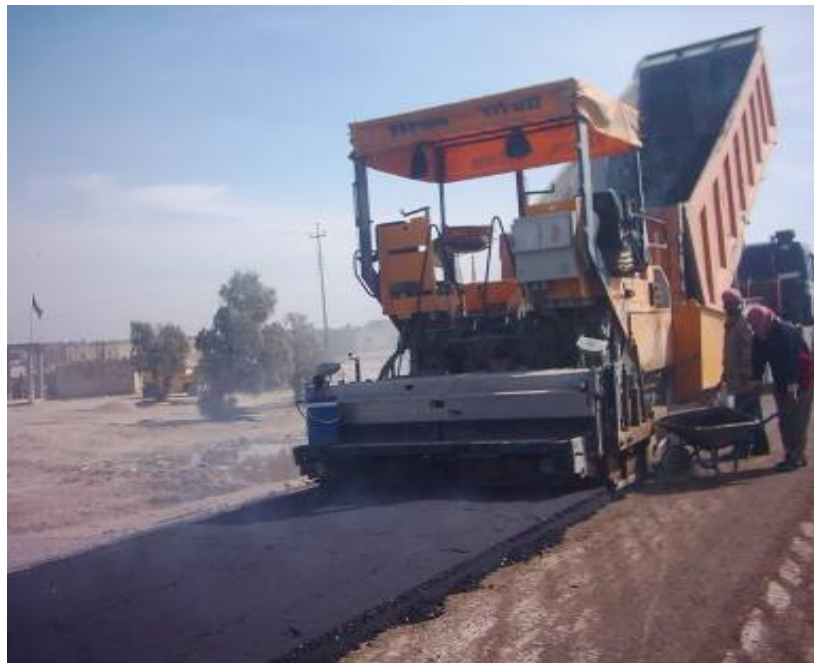
The contractor utilized a self-propelled paver for spreading asphalt concrete. The haul trucks carrying the asphalt concrete from the mixing plant, directly deposited their load into the paver hopper as shown in Site Photo 5.

Site Photo 5. Placing and spreading asphalt concrete pavement –Photo provided by USACE

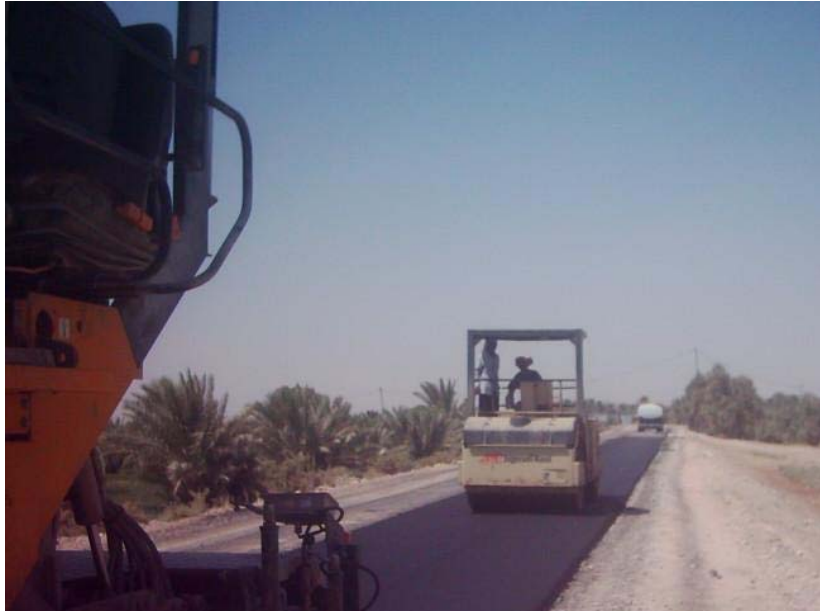
Site Photo 6. Steel wheel roller behind paver compacting the asphalt concrete layer – Photo provided by USACE

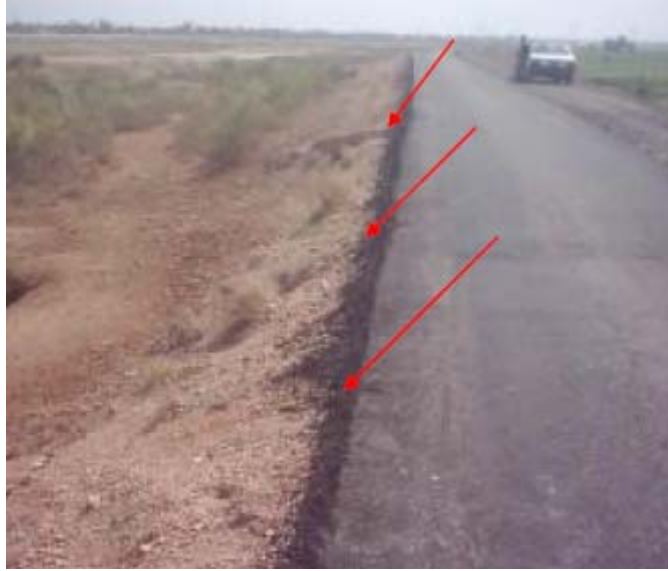
Site Photo 9. Asphalt mix sloughing off along pavement edge due to poor sub-base and fill construction – Photo provided by USACE

The QAR's deficiency log indicated the contractor took corrective action to fix the prime coat problems. According to the USACE RE, the pavement edge problems will not be corrected until the 1.75 m wide shoulders are in place alongside the paved base layer. Once the shoulder work is complete the deficient pavement areas will be repaired to their required widths. In the case of the problems shown in Site Photo 9, the USACE RE reported the road will be repaired when the additional borrow is available to widen the roadway fill structure (Diagram 3) in order to obtain the required section widths for the sub-base, pavement, and shoulders.

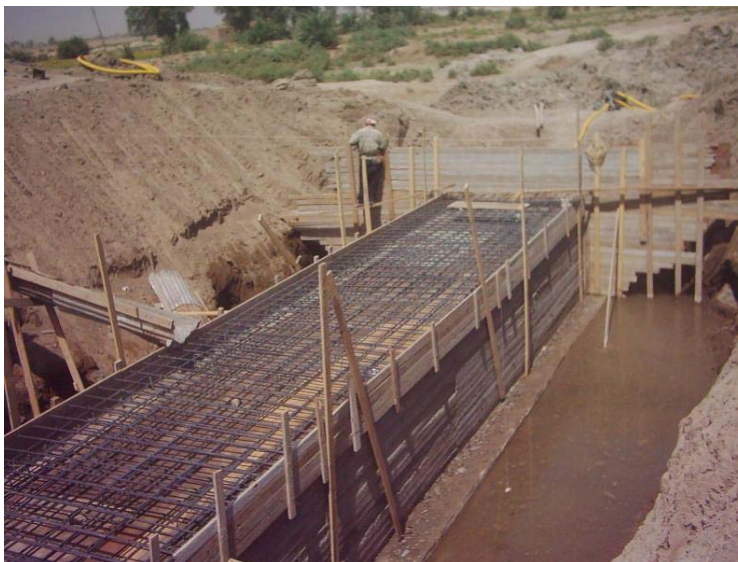
Site Photo 11. Construction of reinforced concrete box culvert – Photo provided by USACE.

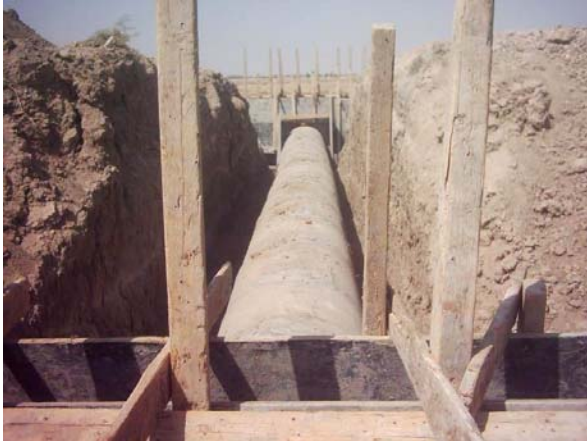
**Site Photo 12. Pipe culvert in trench –
Photo provided by USACE**

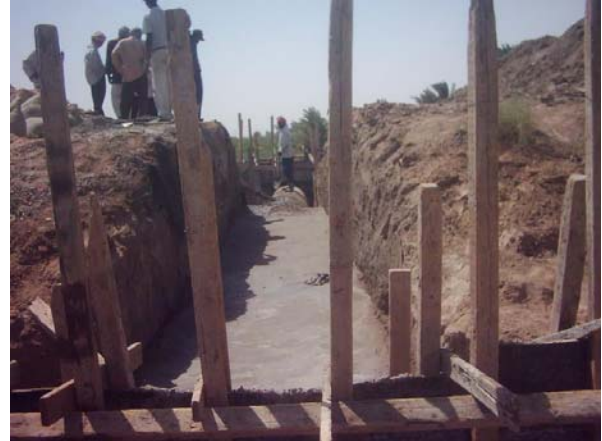
**Site Photo 13. Pipe culvert encased in concrete –
Photo provided by USACE**
